PERCH POND DAM

NDI ID NO. PA-00135
DER ID NO. 64-23

PHASE I INSPECTION REPORT
NATIONAL DAM INSPECTION PROGRAM

AUGUST 1981

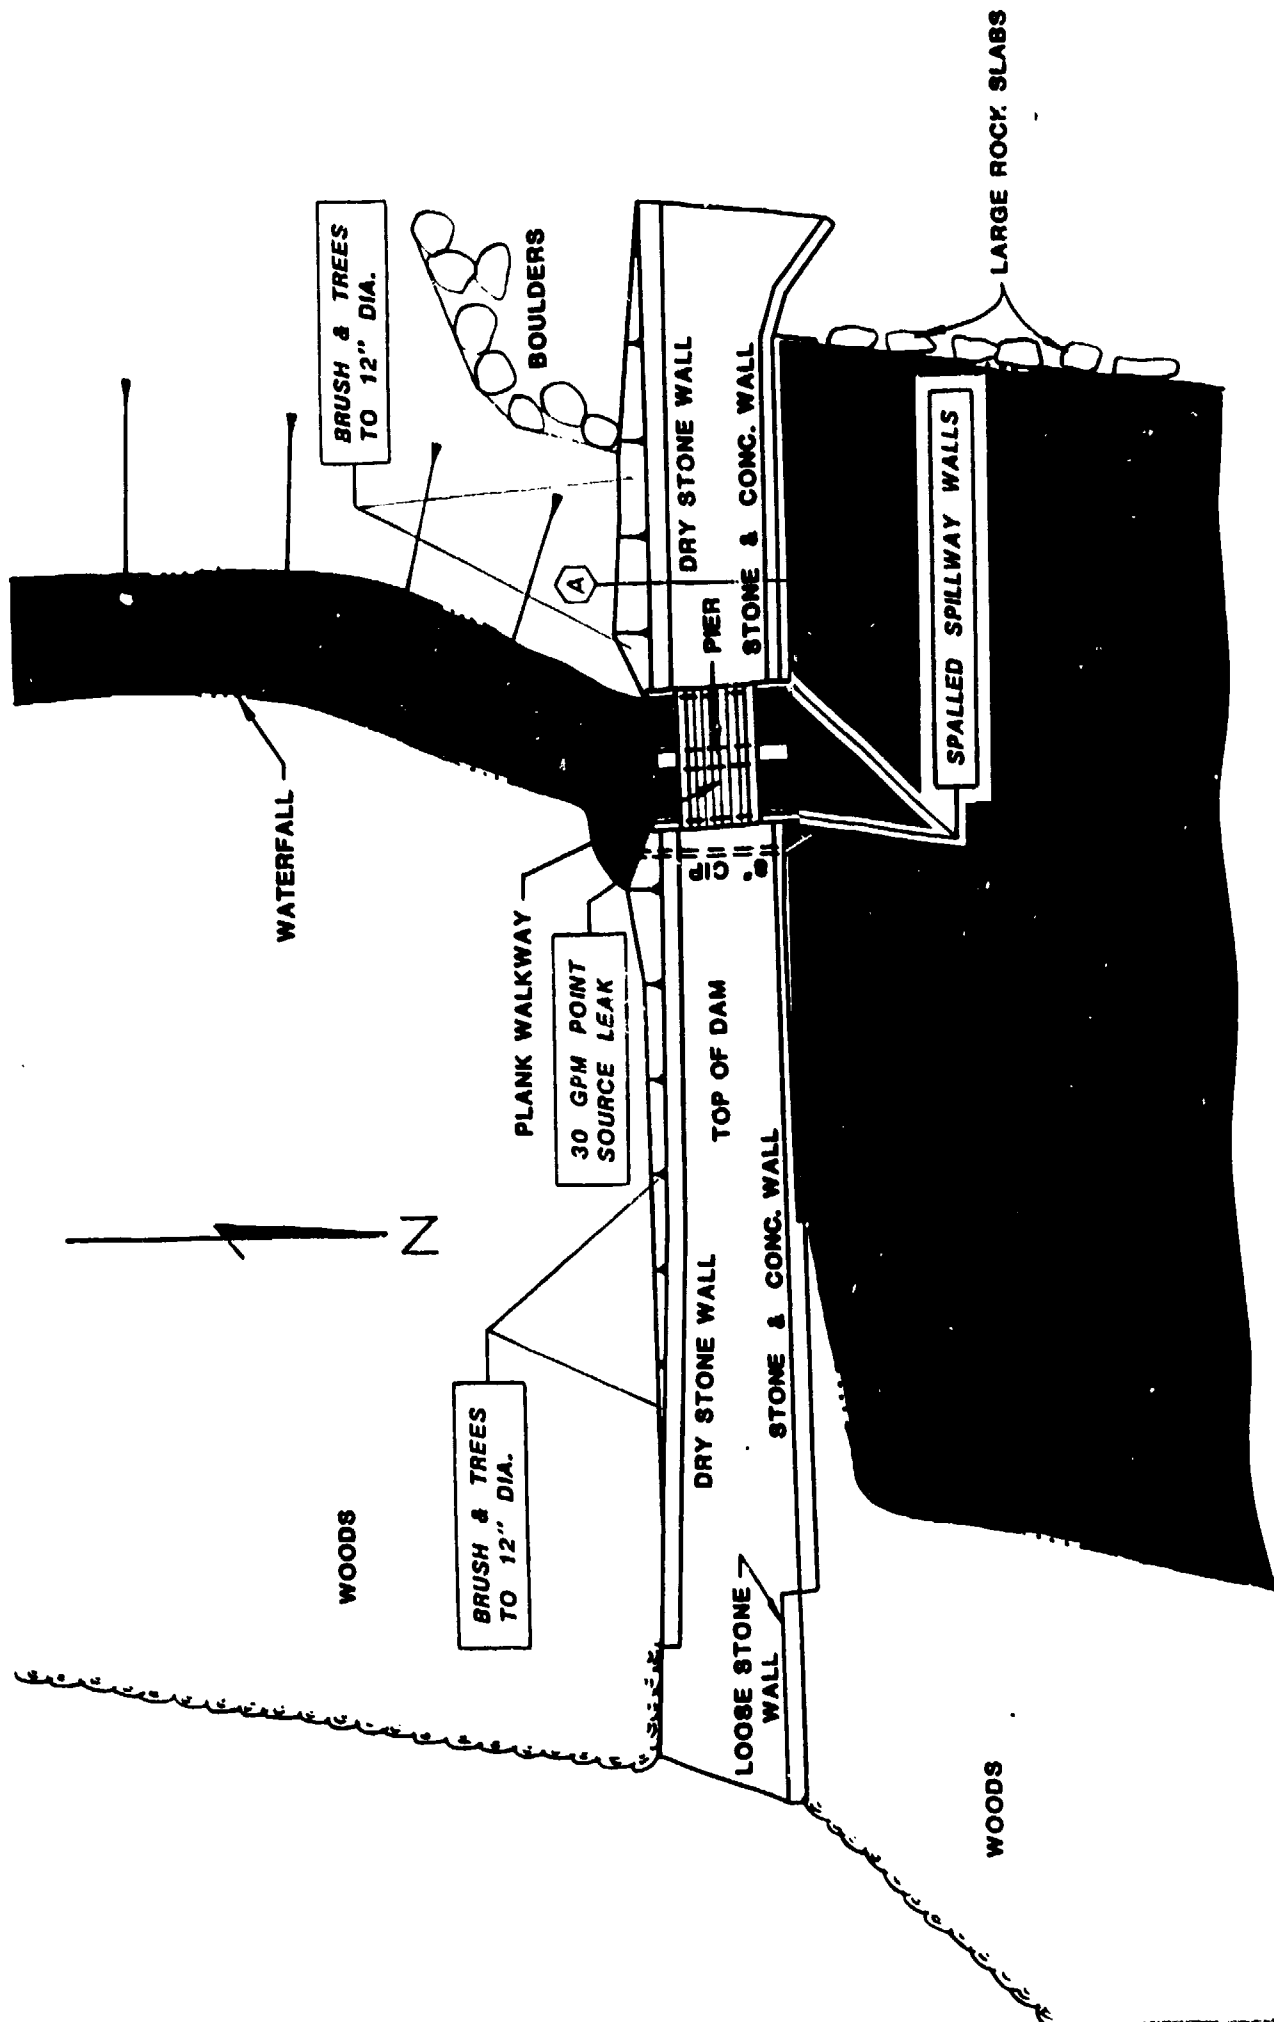
PERCH POND DAM
GENERAL PLAN - FIELD INSPECTION NOTES

a. General: The overall appearance of the dam and appurtenances is fair. A plan of the dam and annotated field observations are shown on Exhibit A-1, Appendix A. Surveyed profiles and typical sections of the dam are presented in Exhibits A-2 and A-3. The survey datum for this inspection is based on the lake elevation shown on the USGS 7.5 Minute Quadrangle (see Exhibit E-1). Pertinent observed features are indicated on the photographs in Appendix C.
